# WATERPROOFING AND TRUTH

**It is not always easy to find an appropriate waterproofing system and to use same correctly**

Dipl.-Ing. Ralf Papendick and Rechtsanwalt Thorsten Boekhoff, Leer

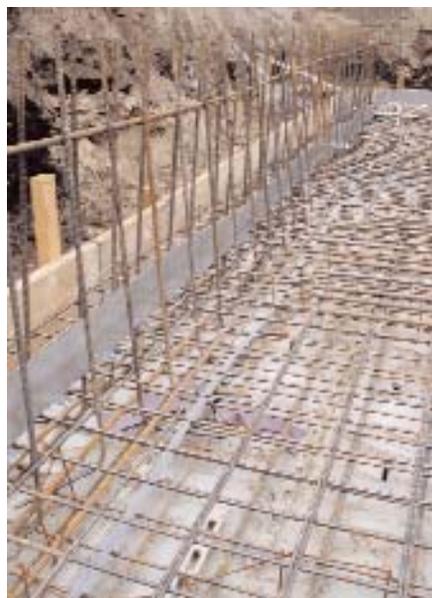
Fig. 2: the classic method – waterproofing the construction joint for the wall-floor junction of a basement with a joint profile (e.g. TRICOSAL). Those who want added security should additionally install an injection hose which can be injected with a resin if needed.

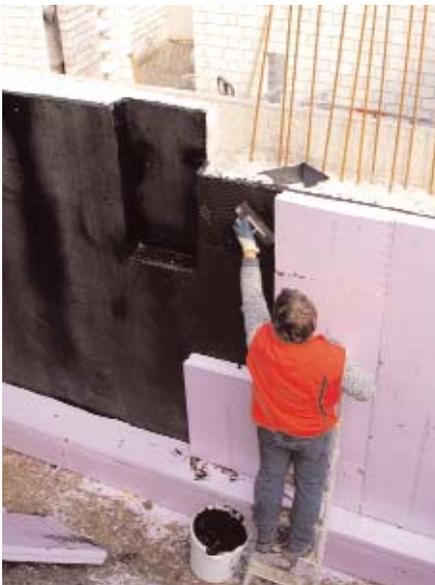
Fig. 4: When waterproofing a basement from the outside, the following details have to be observed: execution of the base area with rot-proof insulation. The transition from the masonry to the foundation is executed as a rounded out fillet. Important: the fillet must have dried prior to application of the primer. The thick film sealant can delaminate if it is applied on a fresh fillet which then shrinks during its drying process. The planning folder of the company DÖRKEN on the DELTA-system contains very good detail solutions and drawings.

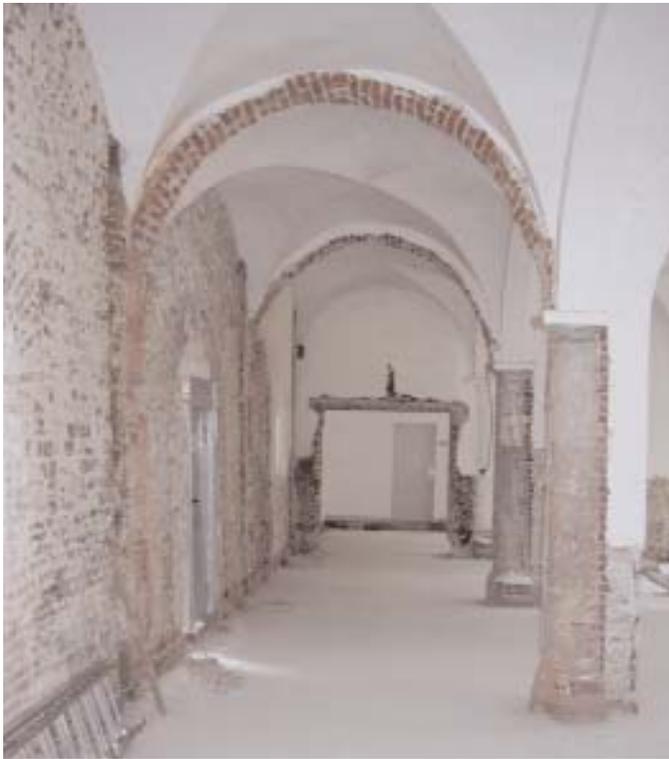
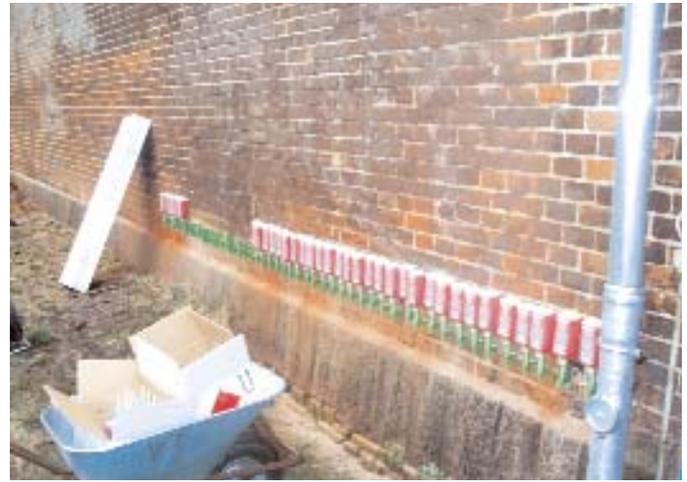
Fig. 8 a, b:  
Horizontal  
waterproofing  
at a listed building

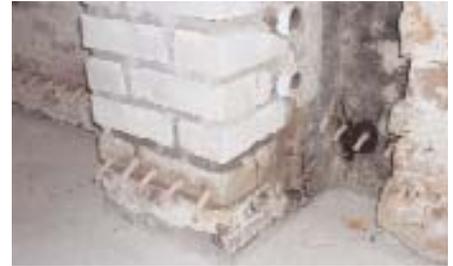
Fig. 7:  
Renovation of the  
royal stables of the  
local court of Aurich  
with KÖSTER Crisin 76

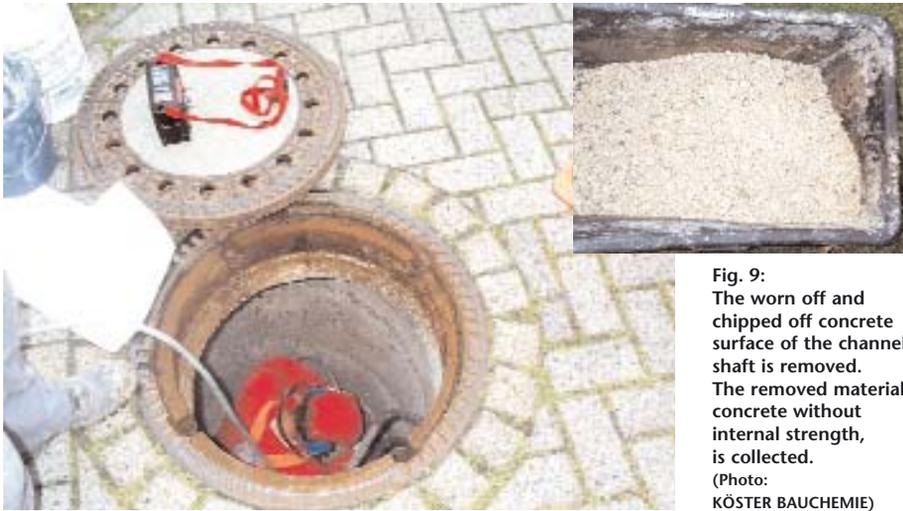
**Fig. 9:**  
The worn off and chipped off concrete surface of the channel shaft is removed. The removed material, concrete without internal strength, is collected.  
(Photo: KÖSTER BAUCHEMIE)

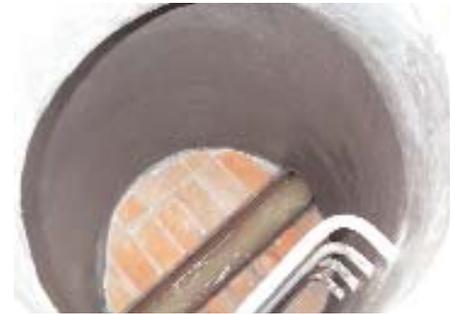
**Fig. 10:** completely renovated manhole after being coated with polymer silicate mortar  
(Photo: KÖSTER BAUCHEMIE)
